Guardian Fleet Services Airplane Crash Recovery

On June 21, 2022, Red Air flight 203 — an MD-82 aircraft with 140 people aboard — crash-landed at Miami International Airport. The airplane veered off the runway and skidded into a grassy area between the runway and a taxiway.

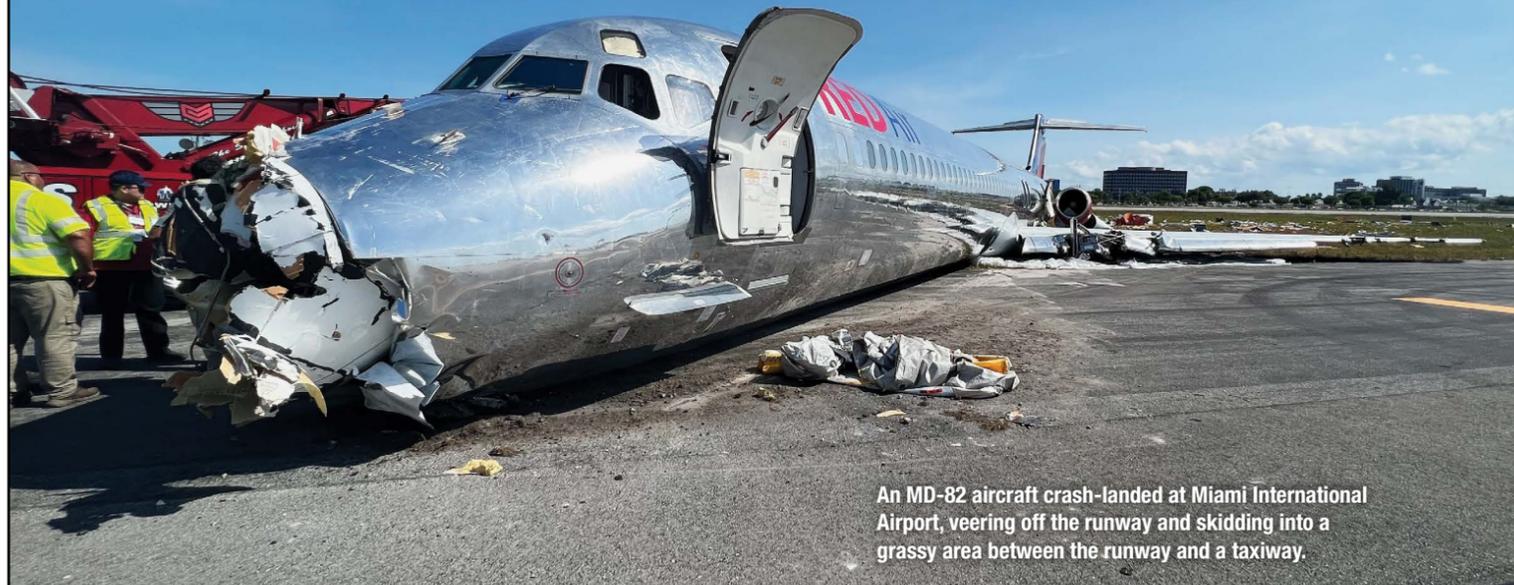
An MD-82 aircraft crash-landed at Miami International Airport, veering off the runway and skidding into a grassy area between the runway and a taxiway.

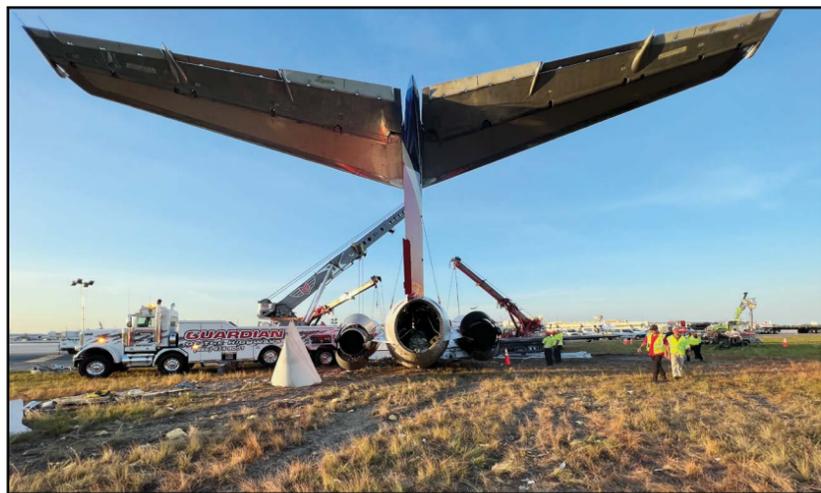
Guardian Fleet Services rotators are moved into position to lift the aircraft.

Three rotators would lift the plane — the two 75-ton rotators were positioned at each wing, while the M100 lifted the rear with a 26-foot-long, 12-inch-wide lifting strap. The 60-ton rotator was in a support and standby mode in case the front of the aircraft needed to be lifted.

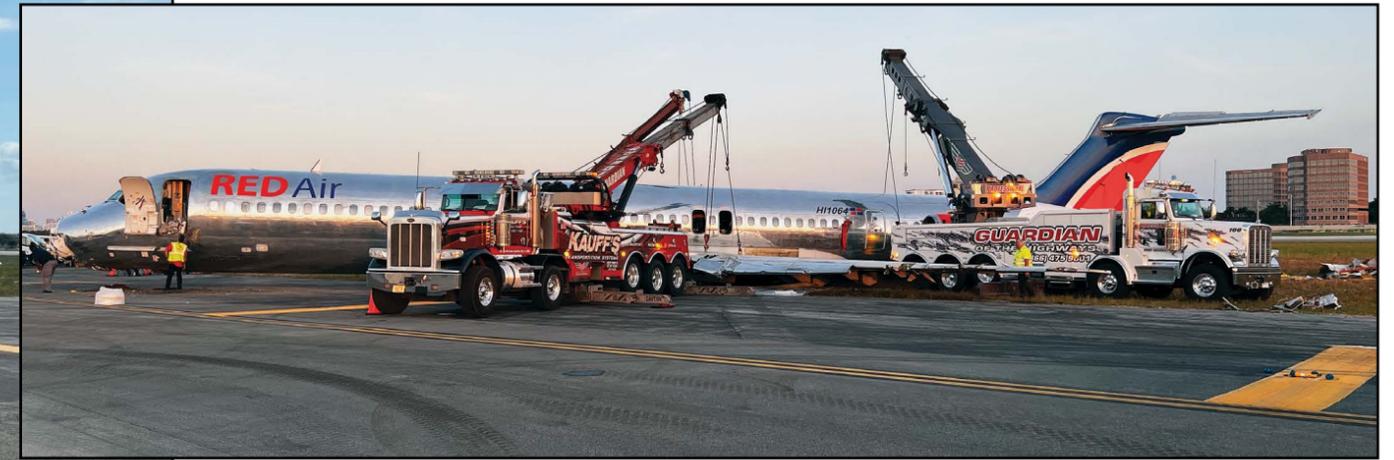
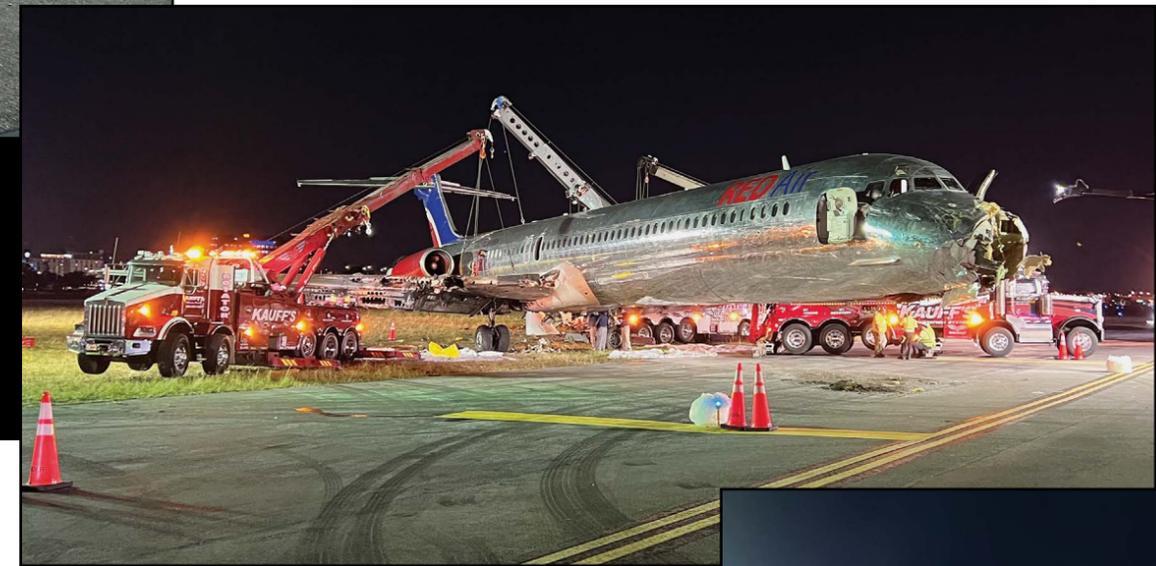
The rotators lifted the plane and suspended it as a specialized trailer cushioned with large, wheeled loader tires was backed under the fuselage.

The tires would provide cushioning for the belly of the aircraft, and disperse the plane's weight. After the rotators slowly lifted the plane, the trailer was backed underneath as the tires were carefully arranged to offer maximum support when the plane was lowered.

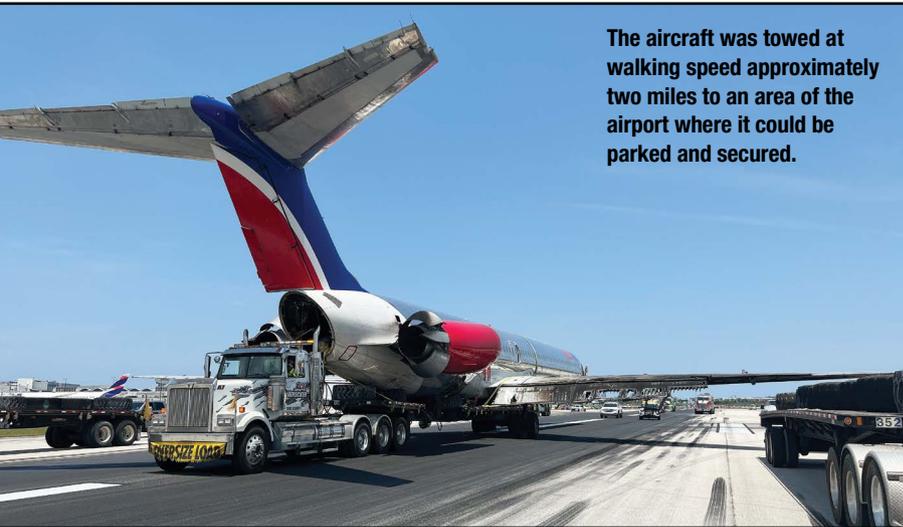
The aircraft was towed at walking speed approximately two miles to an area of the airport where it could be parked and secured.

With the aircraft secured and the escort trailers ready, the recovery team slowly drove the aircraft and its entourage approximately two miles at walking speed from the southeast sector of the airport to the northwest side, constantly monitoring the plane and in constant communication with

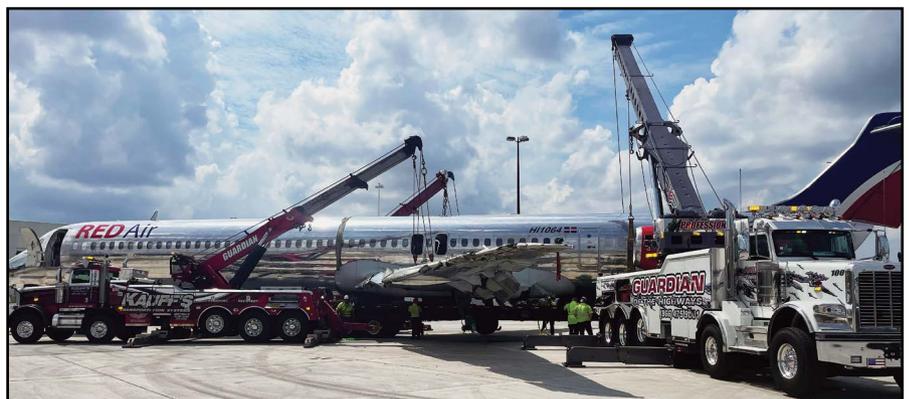
Once at its destination, the rotators lifted the aircraft and placed it on special aircraft support stands.

The aircraft was then lifted, the trailer was removed from underneath, and the support stands were placed at points at the nose, wings and rear. The plane was lowered onto the stands and secured with tie-down chains.
